GROUTING TO MINIMIZE SETTLEMENTS PRIOR TO TUNNEL EXCAVATION – A CASE STUDY

Douglas, M. Heenan¹, P.Eng., Member, ASCE and Michael Xu², Ph.D., P.Eng.

ABSTRACT: Phase I of the Glen Echo Creek Culvert Reconstruction Project, involved lowering the invert of an existing concrete arch tunnel along with replacing an existing corrugated metal pipe (CMP) with a new tunnel between 28th and 29th street in Oakland, California. All construction work was performed within the tunnel by hand mining techniques. Due to the close proximity to residential buildings, roadways and utilities, various grouting techniques were applied to minimize ground settlement, stabilize subgrade soils and reduce water seepage to facilitate hand excavation. This paper describes the design and execution of the various grouting programs implemented, as well as the grouting performance.

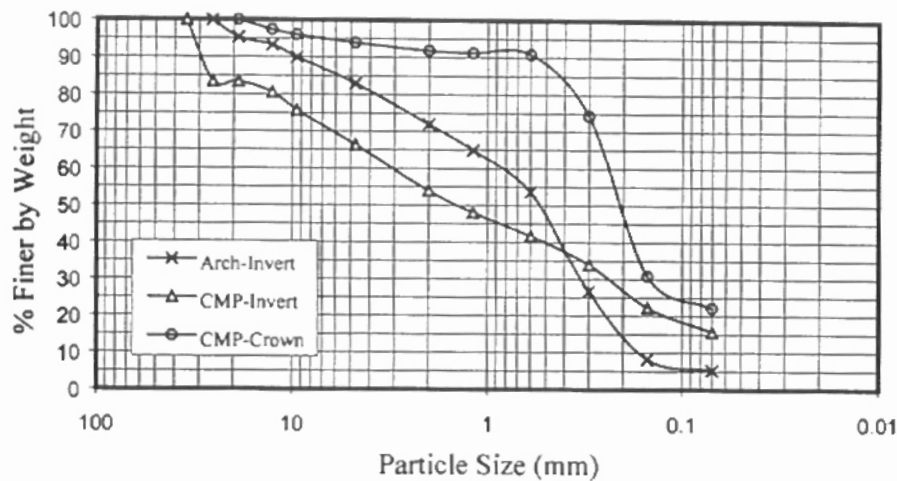
Figure 3. Soil particle size distributions.

Medium stiff to stiff silty clay with sand was present below the fill to a depth of approximately 7.9 m. The borings cored through the walls of the arch culvert encountered sandy clay and silty clay fill at the upstream portion of the culvert from station 26+55 to 25+34, and encountered silty sand from station 24+79 to 24+14. The borings cored through the floor of the arch culvert encountered sand and gravel. The grain size distributions of the subgrade soils are shown in Figure 3, indicating that the soils are not fully permeable at the top of CMP, and partially permeable at the invert of CMP and Arch tunnels.

As indicated by the soil particle distribution, the underlain soils were partially permeable at the invert of arch and CMP. The soil stabilization grouting was actually a combination of permeation and fracture grouting. Permeation and fracture grouting program was designed and performed, in order to stabilize the subgrade soils and facilitate lowering the culvert invert of the arch concrete tunnel, and the enlargement of the CMP. Sodium silicate solution grout was chosen for the intended purpose.

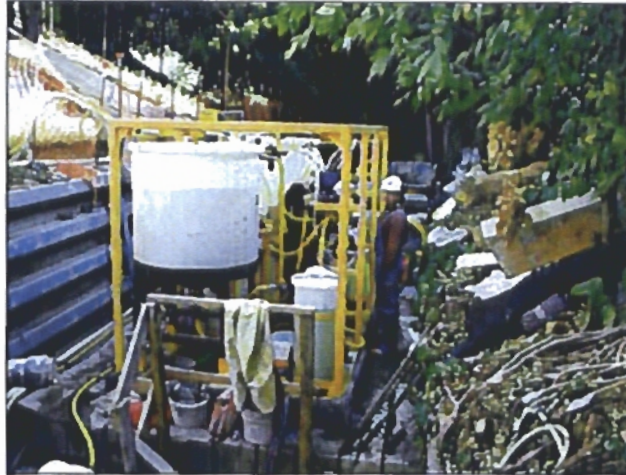
Figure 4. Sodium silicate grout plant.

A sodium silicate grout plant (refer to Figure 4) was custom designed and commissioned for mixing and pumping the sodium silicate grout. A grout delivery system was installed throughout the tunnel with a header system used at point of placement. The grout plant was located outside the tunnel at the east end portal lay down area. The grout injection system consisted of a piston type two component pump with a 1 to 1 ratio. The hardener was pre-mixed with water as component A, and the sodium silicate solution as component B. Components A and B were pumped separately to the point of injection and combined at the header in a static in-line mixer prior to entering the soil.

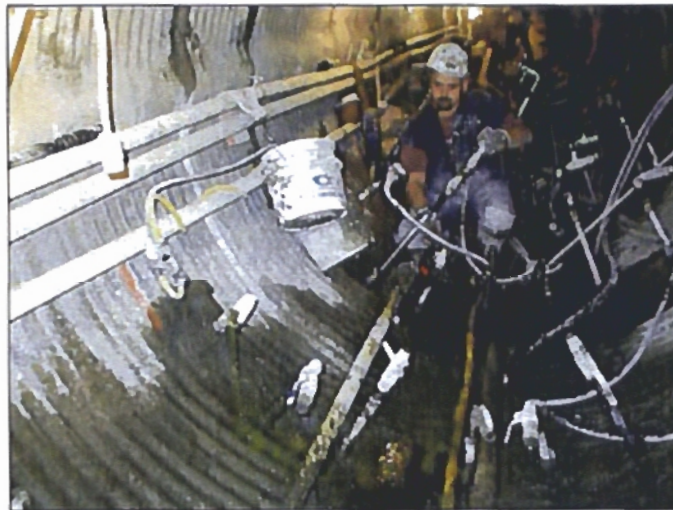
Figure 6. Permeation/fracture grouting and compensation grouting at CMP.

At the CMP, permeation/fracture and compensation grouting were carried out simultaneously as shown in Figure 6. Figure 7 shows the grout takes at the CMP, with an average of approx. 2 m³ and 1 m³ of sodium silicate grout and cement grout, respectively. After completion of all grouting work at the CMP, the excavation was started. It was observed that there was no soil loss occurring and the grouted soils were very stable, as shown in Figure 8. As a result, the open excavation could be carried out with longer segments during each cycle without the need of temporary support, typically 5.5 m, as compared with anticipated 1.8 m per cycle.

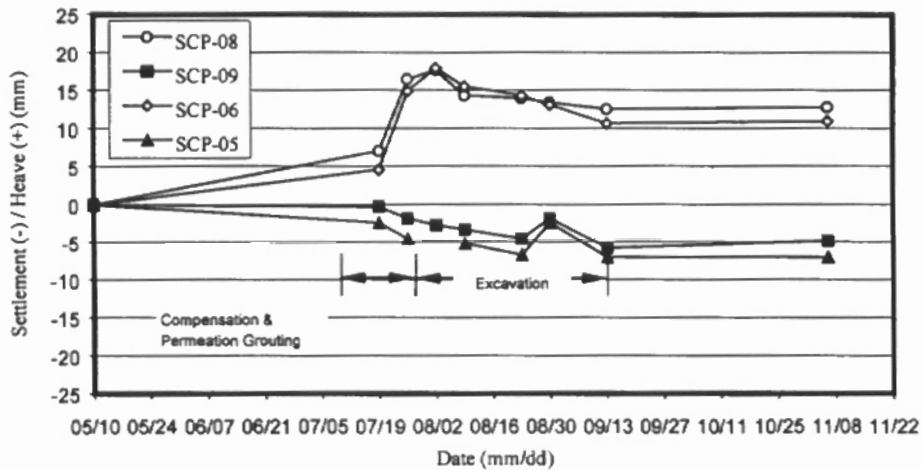
Figure 10. Movements during construction at CMP.

As indicated in Figure 10, the maximum ground settlement was 15.8 mm during construction at SCP-15 and 8 mm after construction at SCP-13 on the East side of the tunnel, in close proximity to the three-story church. The maximum ground settlement was 10 mm during construction and 3 mm after construction at SCP-16 on the West side of the tunnel. The maximum settlement on the roadway was 6 mm. No damage to the adjacent buildings were observed or recorded.

A maximum ground heave of 18 mm was intentionally created at the crown of CMP, which then settled to 12 mm after construction. A maximum settlement of 15 mm was observed at SCP-10 on the parking lot, and 7 mm at SCP-05, which was farther away from the CMP. No damage to adjacent buildings or roadway was observed or recorded.

Prior to and during grouting and excavation, elevation changes of ground surface, buildings and sub-grade soil were closely monitored using various monitoring techniques. The layouts of surface control points are shown in Figure 1. The ground movements at Arch and CMP are shown in Figures 9 and 10.
